***South Hills Environmental Management Consultants, LLP***

### Report on Health Advisory Follow-up

<b>System:</b>	Columbia Falls Aluminum Co.	<b>PWSID:</b>	00906
<b>Address:</b>	2000 Aluminum Drive Columbia Falls, MT 59912		
<b>Phone:</b>	892-82121 or 892-3261 for general inquires		
<b>Fax:</b>	892-5317		
<b>Contact Persons:</b>	<ol style="list-style-type: none"><li>1. Sherry Halorin - 892-8288</li><li>2. Steve Wright, P.E., Environmental Manager - 892-8211</li><li>3. Mike Davis, Casting Engineer - 892-8262; cellular 250-3895</li></ol>

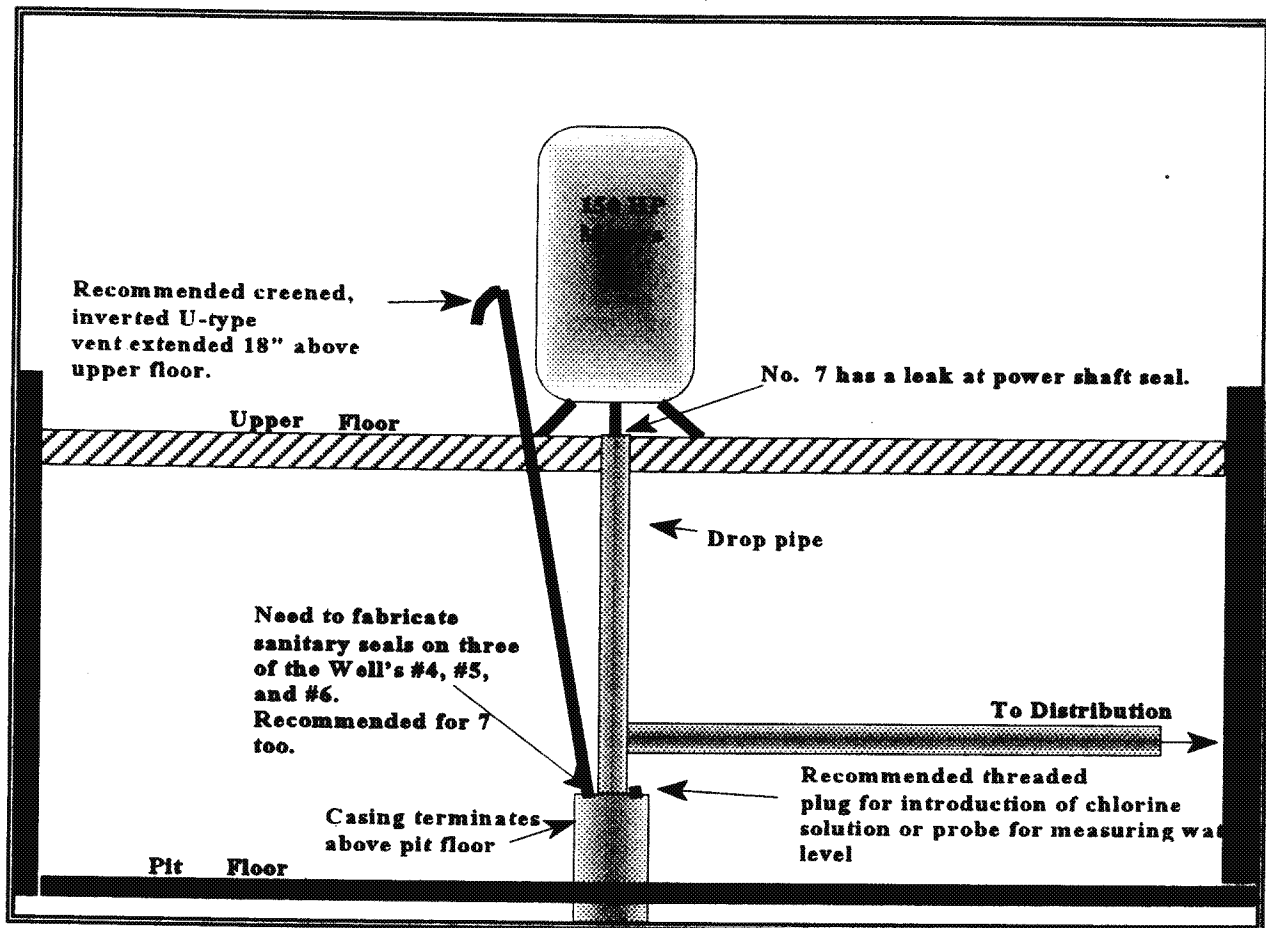
Figure 2. Pump Schematic for CFAC Wells--No Scale

The system is served by 4 high capacity wells. Two are located near the Flathead River and two are closer to the base of Tea Kettle Mountain. Wells number 4 & 5 each have their own pump houses while numbers 6 & 7 are side by side in a larger pump house. Each of the three pump houses has a pit below the main floor. The pump motors and controls are located on the main floors but the well casings terminate below grade in the pits. The casings of wells 4, 5, & 7 are not sealed at the top. Each is open around the drop (eductor) pipe all the way to the water surface.
